Tiny ceramic cell defies toughest process conditions

Christian Langensiepen *

Experiences with a new measuring transmitter for level and pressure

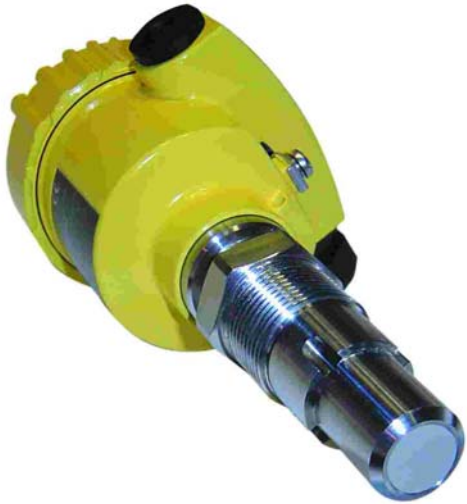
Fig. 1: VEGABAR 54 with process connection for PASVE fitting

That's why the decision was made to implement the new VEGABAR 54 with its small, newly developed ceramic measuring cell. As a leading manufacturer of absolutely front-flush, ceramic-capacitive pressure transmitters for the paper industry, VEGA had already offered solutions to this problem, but not for this special 1" process connection. Thanks to the new VEGABAR 54, the new technology is now available for existing welded sockets and PASVE service fittings.

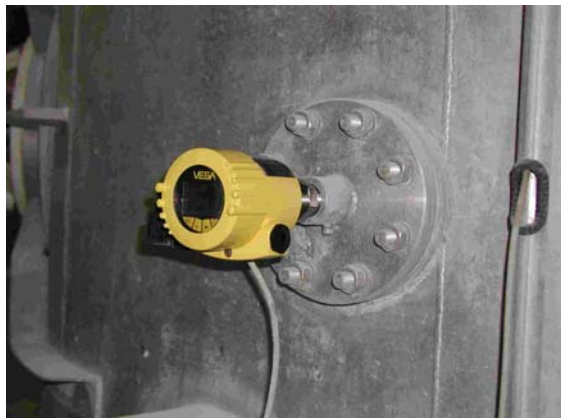
Fig. 2: Measurement site on the reject vat

On the approx. 1.8 m high reject vat, the pressure transmitter is mounted via a weld-on socket and flange. A big problem here is the chalk residue in the rejected material – it deposits as a hardened plaster layer on the diaphragm of the pressure transmitter.

On the reject vat the previous transmitter failed after two weeks because of a clogged diaphragm and could not be cleaned or repaired. VEGABAR 54, on the other hand, was put back in operation after being cleaned with a fine wire brush and an acidic cleaning agent. In the trial run, the ceramic proved to be extremely resistant to abrasion. The typical pressure shocks had no influence on the measuring results.
